Risk assessment for tram traffic on tramway bridges

Keywords: tram infrastructure, sections with steep gradients, risk assessment, design guidelines

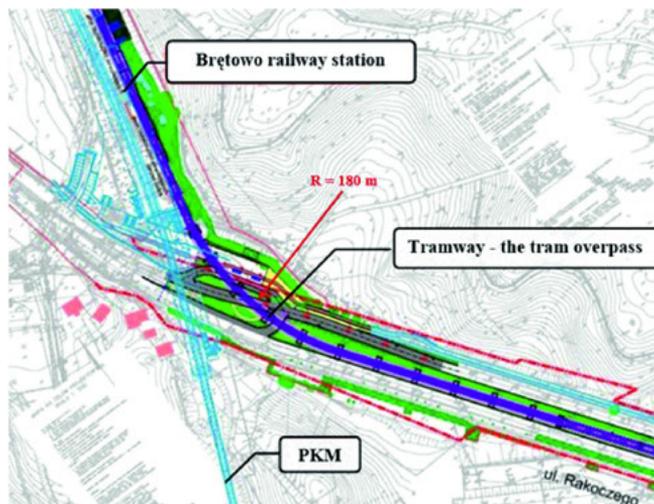
Fig. 1. Diagram of the analysed section of the tramway in Rakoczego street, Gdansk (horizontal alignment and vertical alignment) [10]

In September 2015 a tram line was opened along Rakoczego Street in Gdansk. It connects Morena (a district of Gdansk) with the Pomeranian Metropolitan Railway's (PKM) Bretowo station. On a section of approx. 1.0 km the line runs along a longitudinal decline with varying gradients from 0 to 5%. At 0.3 km from the PKM stop, the line runs along a horizontal curve with a radius of $R = 180$ m. The tram line is connected to the PKM stop by a 362.1 m double-track overpass (Figures 1–4) with a gradient of up to 5%. It stands on thirteen spans, the highest

of which is 9 metres. The tram overpass runs in a curve with a radius of $R = 180$ m and intersects the carriageway and pavement of Rakoczezo St. at a grade-separated junction. It then runs parallel to the tracks of the Pomeranian Metropolitan Railway (PMR) at the Bretowo stop. The design speed for trams due to the horizontal curve (180 m radius) is 30 km/h. However, the permitted operating speed is $Vd = 15$ km/h.

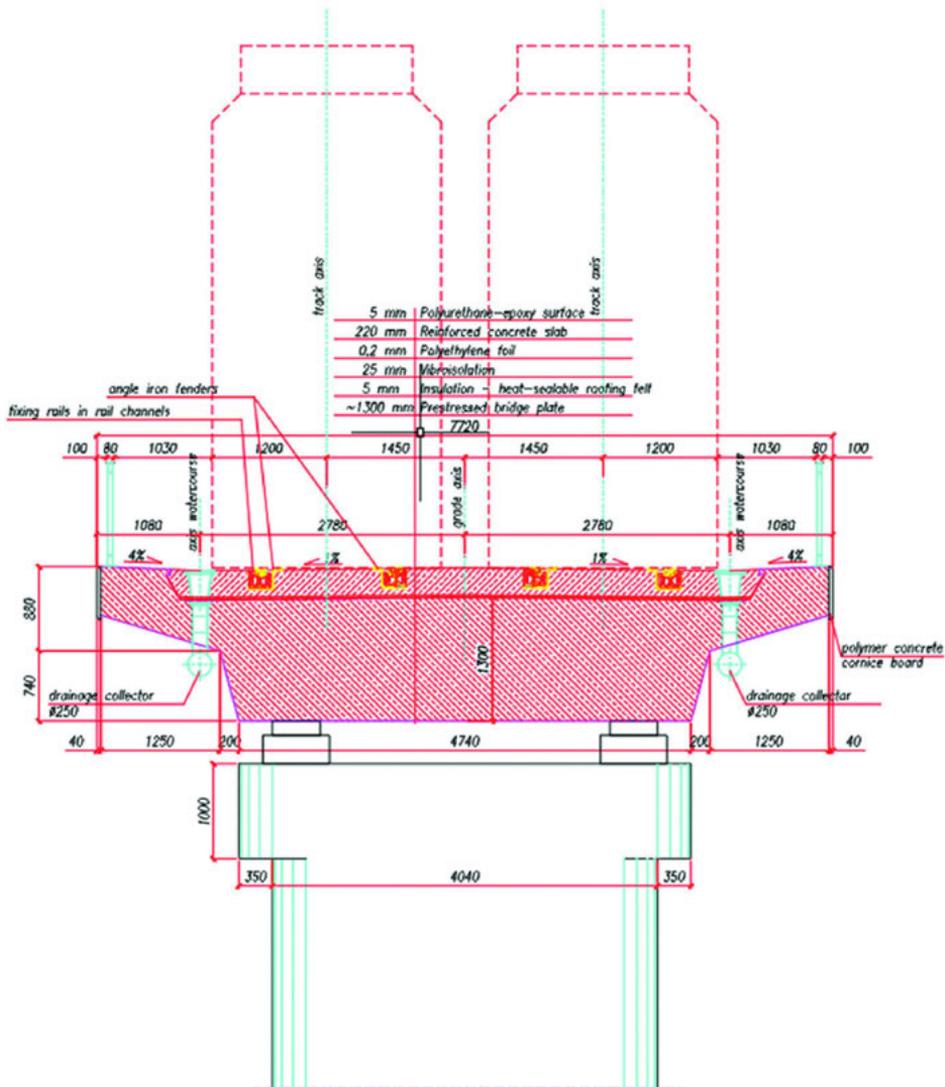
Fig. 2. Diagram of the cross section of the tramway road in Rakoczezo St., Gdansk [10]

The tramway bridge's design rolling stock load is in accordance with PN 85/S-10030. The bridge's static system is made of a continuous, prestressed, 13-span slab with a width of 7.72 m

of which 5.36 m (2×2.68) is occupied by the tracks. The tramway bridge is fitted with steel railings 1.1 m high on both edges fixed to the slab with concrete foundations.

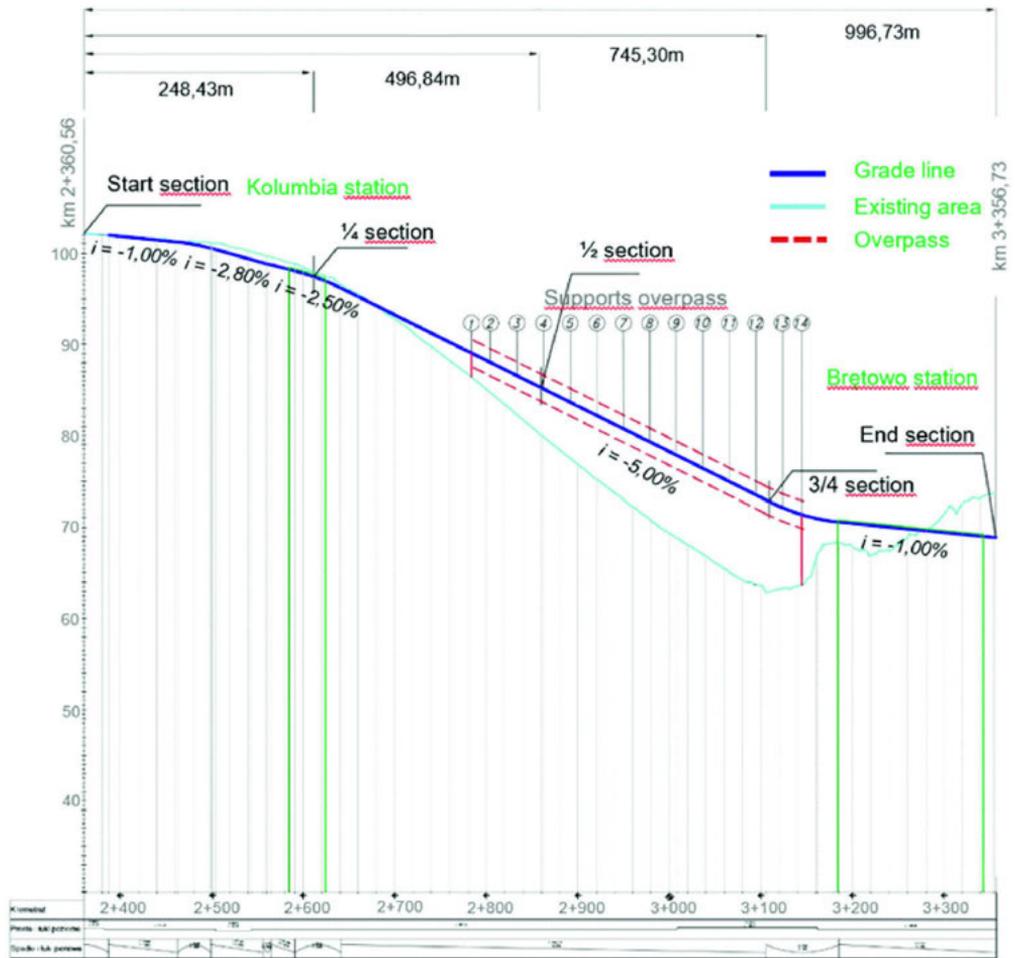
Fig. 3. Diagram of the vertical alignment of the analysed section of the tramway road in Rakoczego St., Gdansk [10]

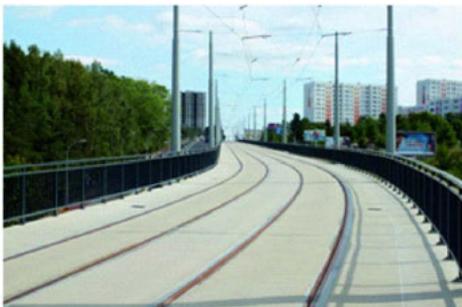
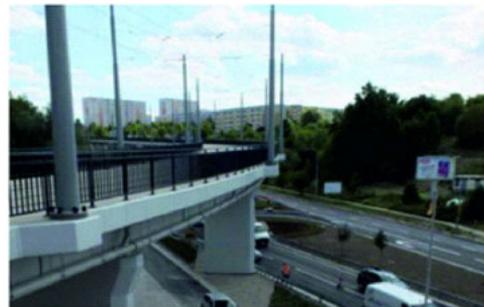
Fig. 4. View of the tramway bridge in Rakoczego St., Gdansk. Source: press materials, trójmiasto.pl

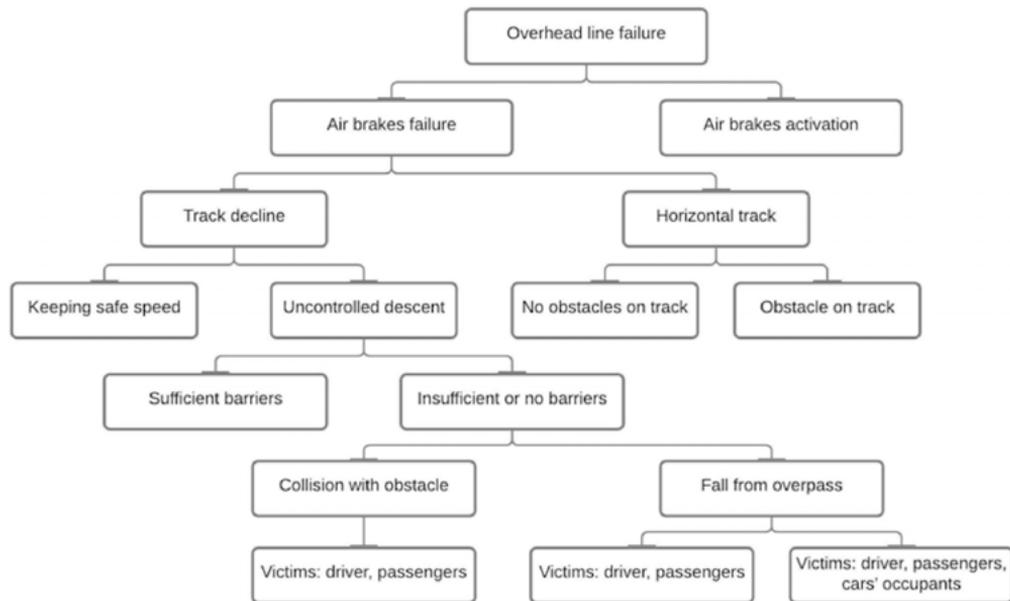
Fig. 5. The cause and effect event sequence during the failure of an overhead contact line – event tree [10]

Three methods were used to identify the risk of hazards: the event tree method, fault tree method and Bow–Tie method [6, 9, 14, 15, 21]. Fig. 5 shows a diagram of the cause and effect event sequence during the failure of an overhead line.

The cause and effect sequence of events presented in the diagram shows that a failure of the overhead contact line may be the initiating dangerous event on the analysed section of tram tracks located on the overpass. Failure of a tram overhead contact line may cause the vehicle to come to a stop slowly when it is on a flat section of the track. However, where a tram is on a section of the track located on a longitudinal decline (during a power failure), the tram car may start to roll (unable to start in-service braking) in a controlled manner (with the possibility of safety or emergency braking) or uncontrolled manner (unable to engage any braking, e.g. failure or deactivation of the braking system).

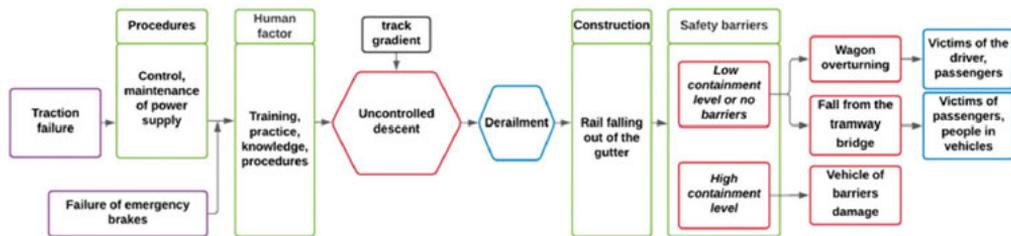
Fig. 6. An example of how hazards are identified in the case of a tram travelling uncontrollably on a tramway located on an embankment or overpass

determined that a tram derailment could have several causes: damage to the rail, failure of the trolley (usually wheels) or foreign material on the tram tracks. Two cases of identified tram hazards along the analysed overpass were analysed using the Bow–Tie method [14, 21]: derailment of the tram and uncontrolled descent along a section with a high longitudinal decline. The latter case poses a major hazard because of the high speed a tram may reach as it travels down an elevation while moving uncontrollably. Figure 6 shows a diagram of the causes and consequences of uncontrolled tram descent on a tramway with a high gradient. The event was also analysed for its causes (Fig. 7). The analysis showed that this may be caused by a set of causes such as: technical failure of traction (traction breakdown or power cut), technical failure of the vehicle (braking system failure, uncontrolled descent), human factor (error or misuse of the braking system), tramway design (high longitudinal gradients, small curve radius, lack of anti-derailment system, lack of safety barriers or no barriers). The analysis helped to identify and provide barriers to prevent the events from happening (elimination of causes) and take actions to mitigate the effects of hazardous events.

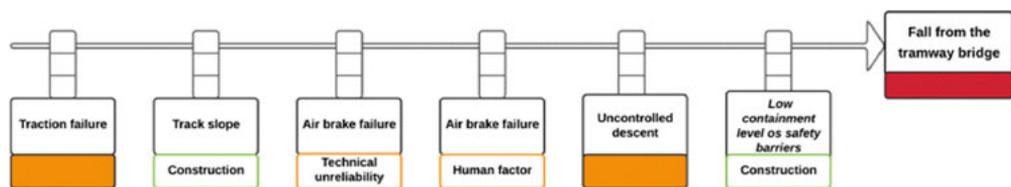
Fig. 7. Path from an initiating event to a selected consequence, a tram falling from an embankment or tramway bridge

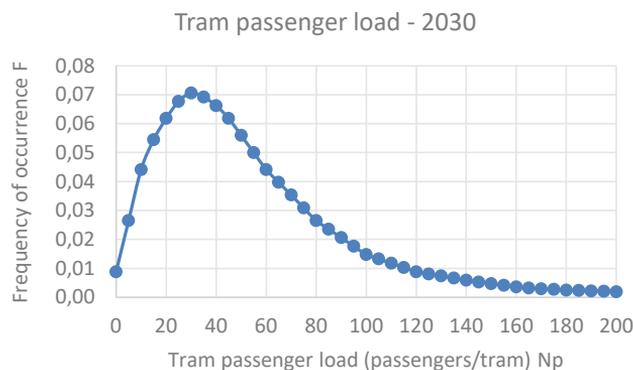
Fig. 8. Distribution of the daily tram passenger load on the analysed section of the line – forecast for 2030 [10]

Probability of a hazardous event. Further analyses used tram passenger load data which were developed on the basis of previous research by the authors. Next, tram traffic forecasts on the analysed line were developed for 2030 and the average daily distribution of tram passenger loads was determined (Fig. 8).

Current research shows that at present the average tram passenger load is about 3 passengers on one tram journey with app. 20 passengers as the maximum value. Forecasts suggest a large increase in the number of passengers with the average passenger load at 54 passengers and the maximum value at up to 200 passengers per tram journey on the analysed section.

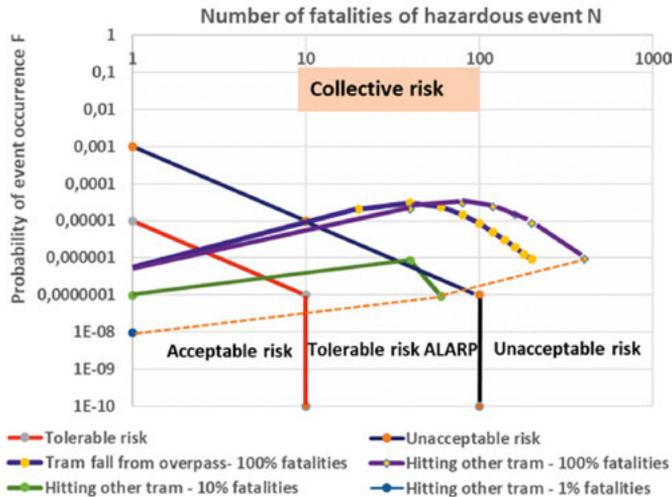
Fig. 9. Distribution of the daily tram passenger load on the analysed section of the line – forecast for 2030 [10]

In the case of collective risk, the EU recommendation [25] was used and a classification dedicated for the needs of tram traffic safety assessment was proposed. Its boundaries are shown in Figure 9. Group risk assessment involves the following steps:

Figure 8 presents graphs of changes in the probability of the potential number of fatalities depending on the number of passengers in the tram (the forecasted passenger load for 2030 was assumed) and the type of a possible hazardous event as a result of an uncontrolled tram descent (falling from an overpass or hitting another tram) [16] against the assumed acceptability limits of group risk.

Using the risk accessibility limits shown in Fig. 9, the level of risk acceptability of a certain number of fatalities in a tram accident was determined. The presented results indicate that the effects of one hazardous event occurring in 30 years, involving an uncontrolled descent of a tram on a steep tramway and falling from an overpass or hitting another tram, poses a very high risk to passengers even at a moderate tram load. In these cases, the **collective risk** of a tram safety hazard on the analysed section of the tramway will be **at an unacceptable level**.
